Old Oakland Road Habitat Mitigation Project
Story Road Mitigation Site #2

Year 4 (2008) Monitoring Report

Kathleen Lyons, Plant Ecologist

December 15, 2008

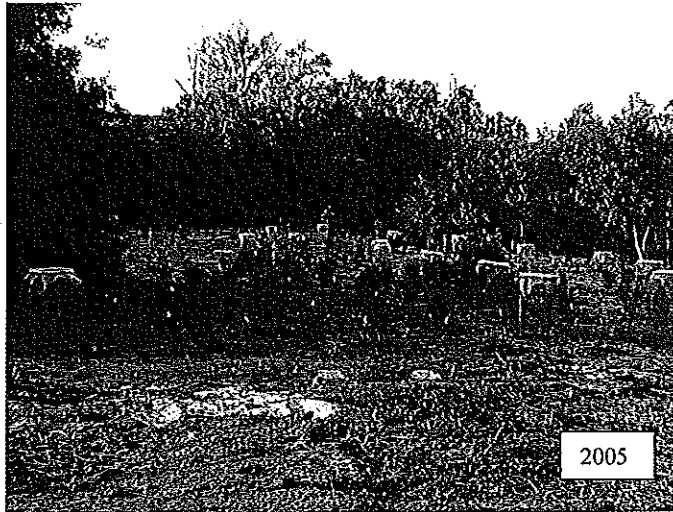
Figure 3. View of westernmost portion of riparian planting area, October 2005. (Photo station #1)

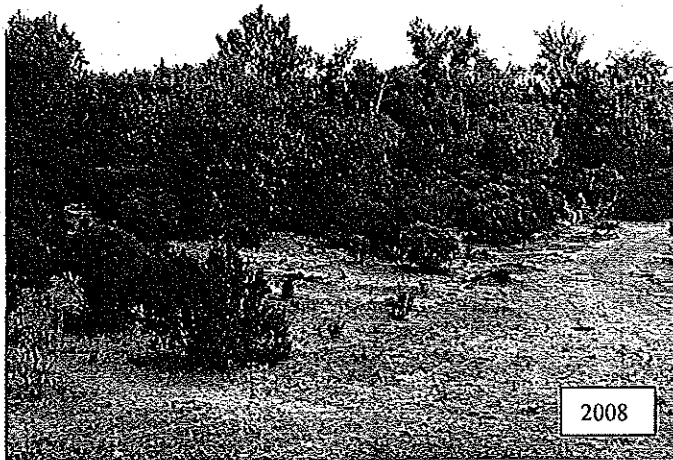
Figure 4. View of westernmost portion of riparian planting area, September 2008. (Photo station #1)

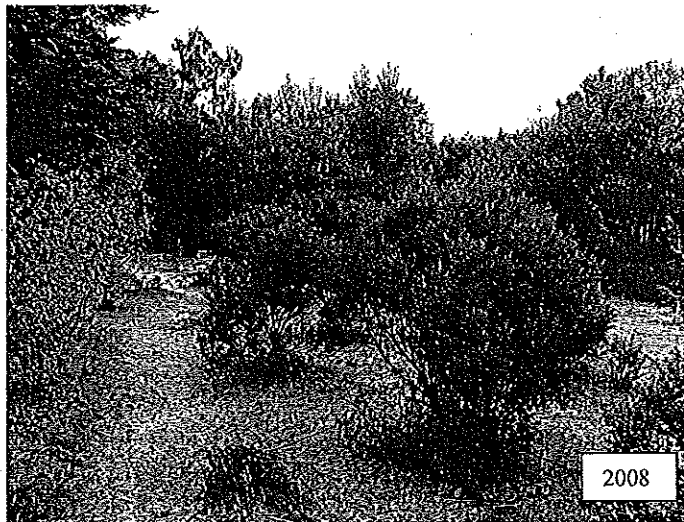
Figure 7B. View of Sample Plot 1, September 2007. Herbaceous/bare cover is 25%; shrub cover is 60% and tree cover is 15%.

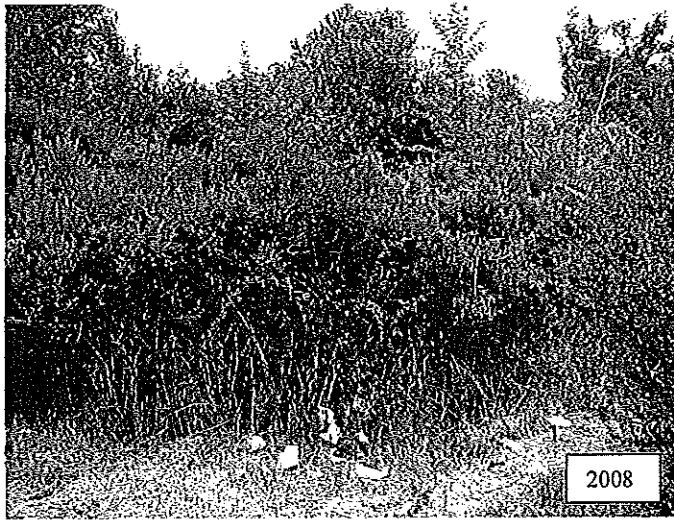
Figure 8B. View of Sample Plot 2, September 2008. Herbaceous/bare cover is 5%; shrub cover is 90% and tree cover is 0%. Weeds include tree-of-heaven.

The City should remove trees/tree groves of tree-of-heaven (invasive species) that abut the mitigation area. This tree removal plan is presented in Appendix A. The removal of these invasive trees will provide long-term benefits to the mitigation area, as tree-of-heaven can aggressively invade the mitigation area once maintenance activities cease.

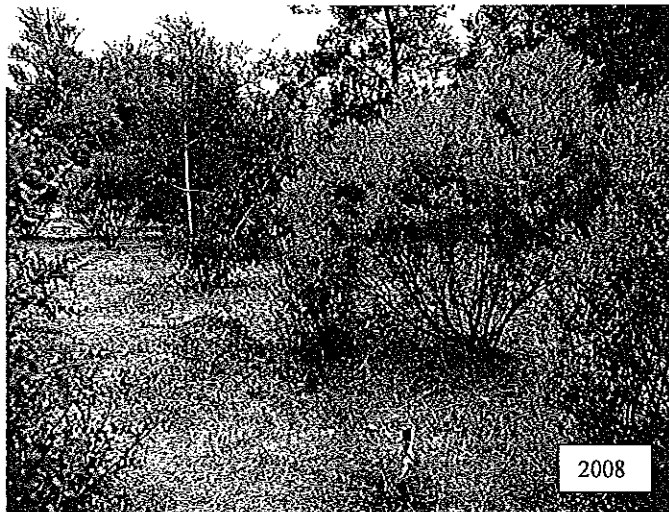
Figure 9B. View of Sample Plot 3, September 2008. Herbaceous/bare cover is 10%; shrub cover is 75% and tree cover is 15%.

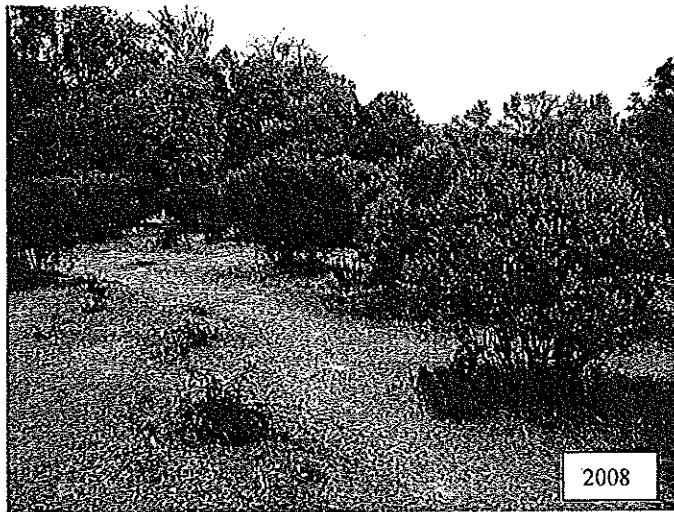
Figure 10B. View of Sample Plot 4, September 2008. Herbaceous/bare cover is 30%; shrub cover is 70% and tree cover is 0%.

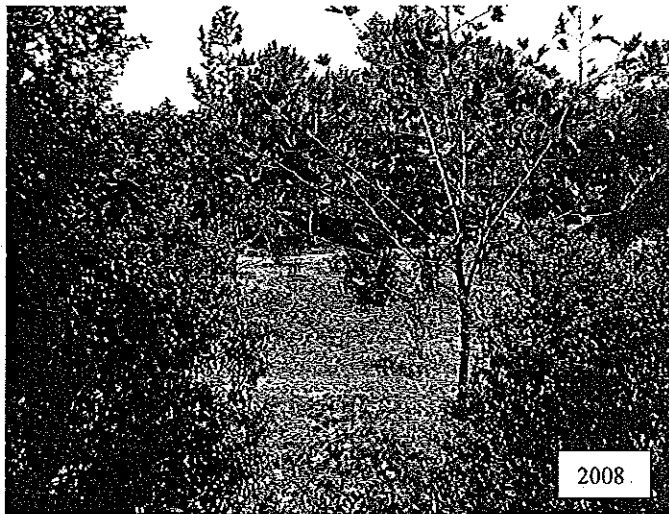
Figure 11B. View of Sample Plot 5, September 2008. Herbaceous/bare cover is 40%; shrub cover is 30% and tree cover is 30%.

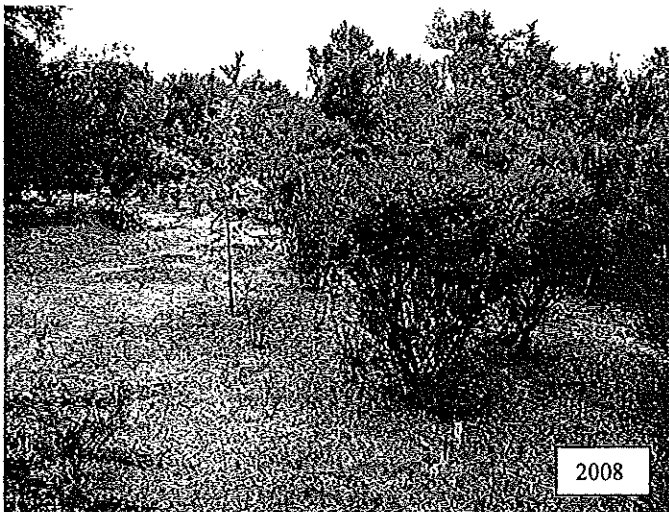
Figure 12B. View of Sample Plot 6, September 2008. Herbaceous/bare cover is 50%; shrub cover is 30% and tree cover is 20%.

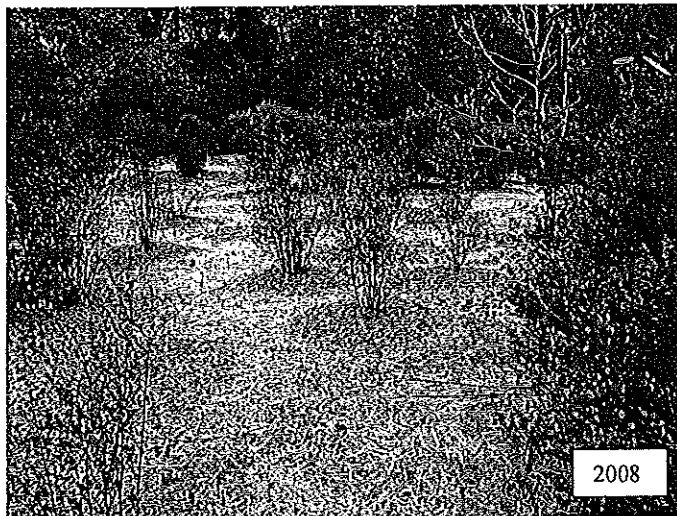
Figure 13B. View of Sample Plot 7, September 2008. Herbaceous/bare cover is 40%; shrub cover is 50% and tree cover is 10%.

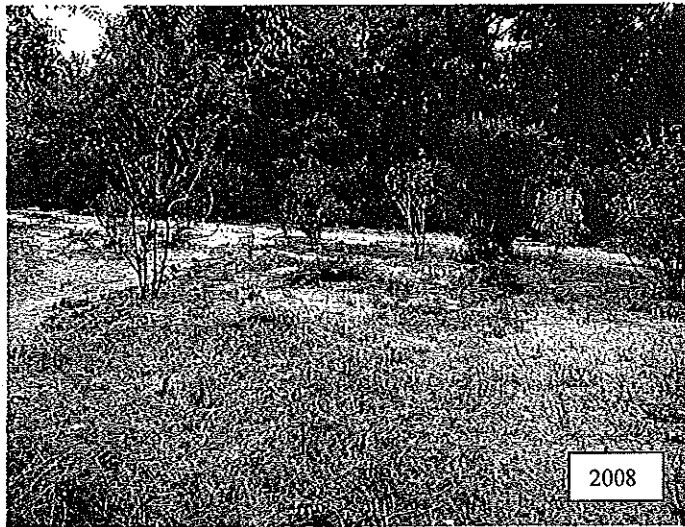
Figure 14B. View of Sample Plot 8, September 2008. Herbaceous/bare cover is 30%; shrub cover is 50% and tree cover is 20%.

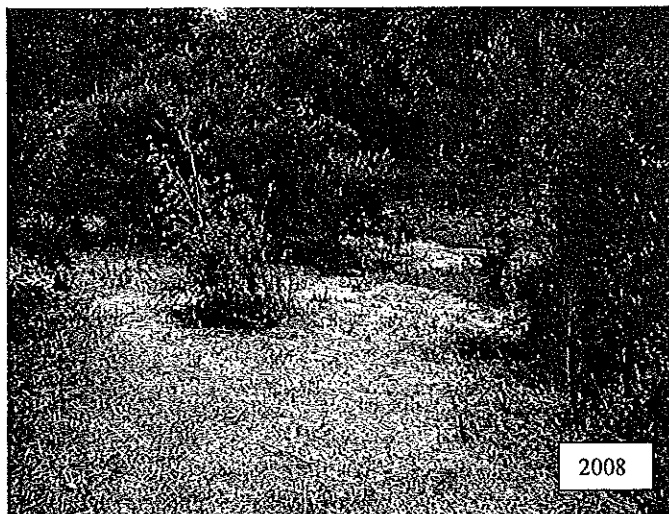
Figure 15B. View of Sample Plot 9, September 2008. Herbaceous/bare cover is 40%; shrub cover is 50% and tree cover is 10%.

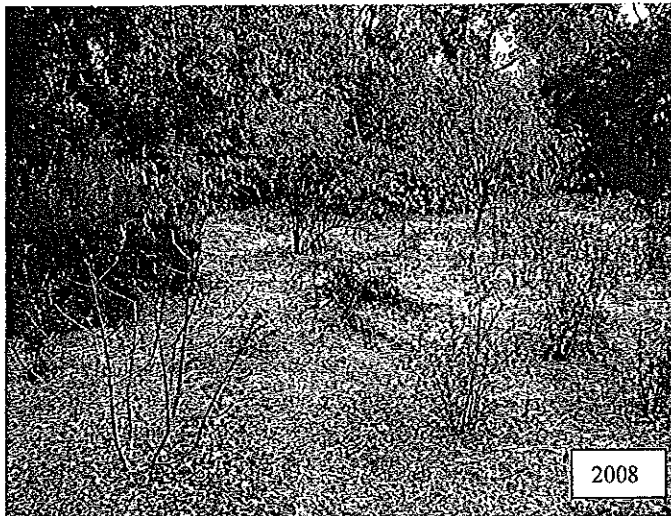
Figure 16B. View of Sample Plot 10, September 2007. Herbaceous/bare cover is 50%; shrub cover is 40% and tree cover is 10%.

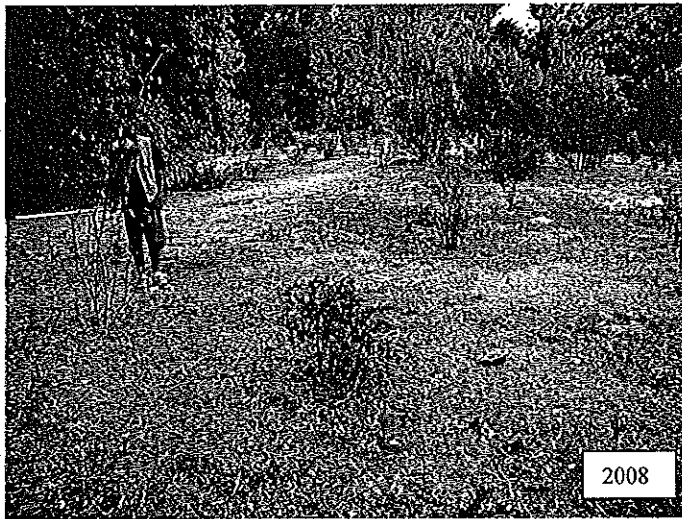
Figure 17B. View of Sample Plot 11, September 2008. Herbaceous/bare cover is 75%; shrub cover is 20%, tree cover is 5%.

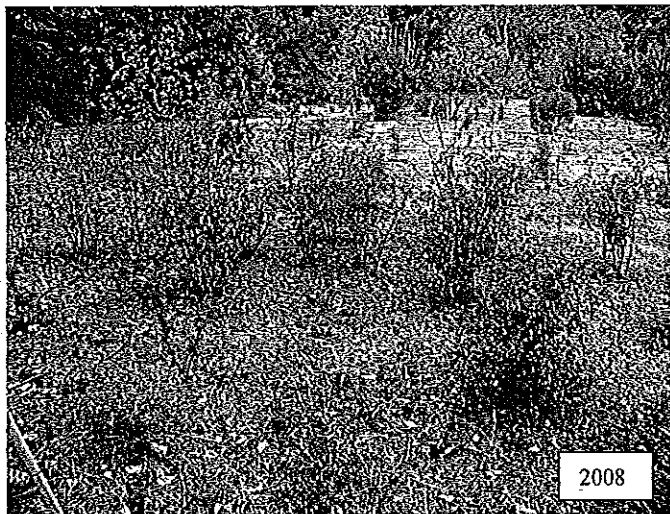
Figure 18B. View of Sample Plot 12, September 2008. Herbaceous/bare cover is 20%; shrub cover is 75%, tree cover is 10%.

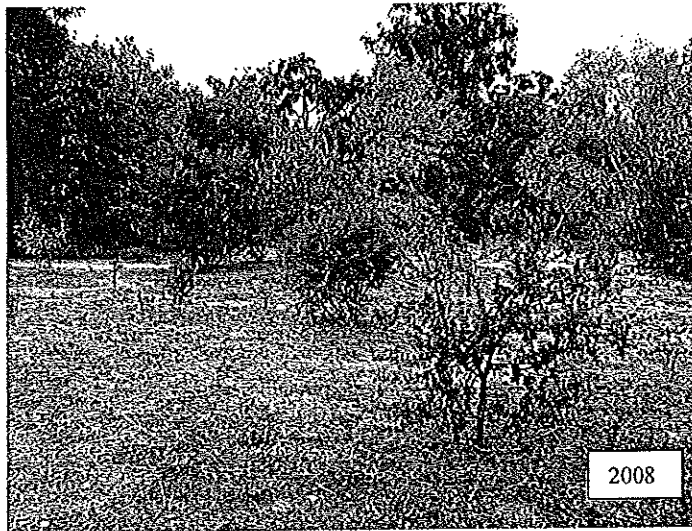
Figure 19B. View of Sample Plot 13, September 2008. Herbaceous/bare cover is 75%; shrub cover is 20%, tree cover is 10%.

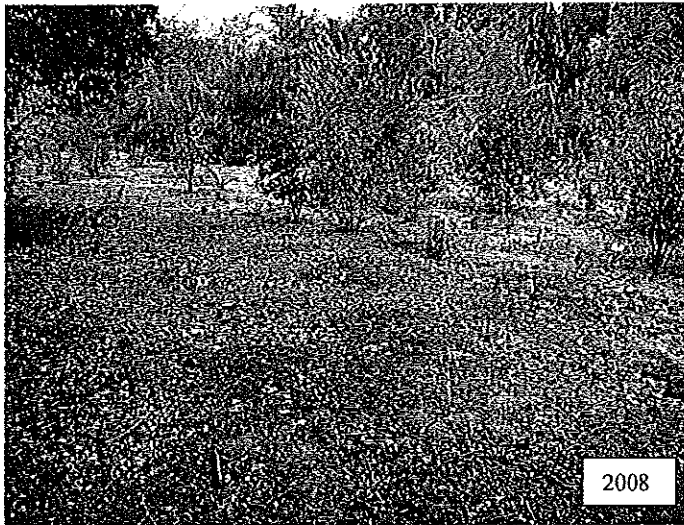
Figure 20B. View of Sample Plot 14, September 2008. Herbaceous cover and bare is 90%; shrub cover is 10%, tree cover is 0%. Weeds include tree-of-heaven.

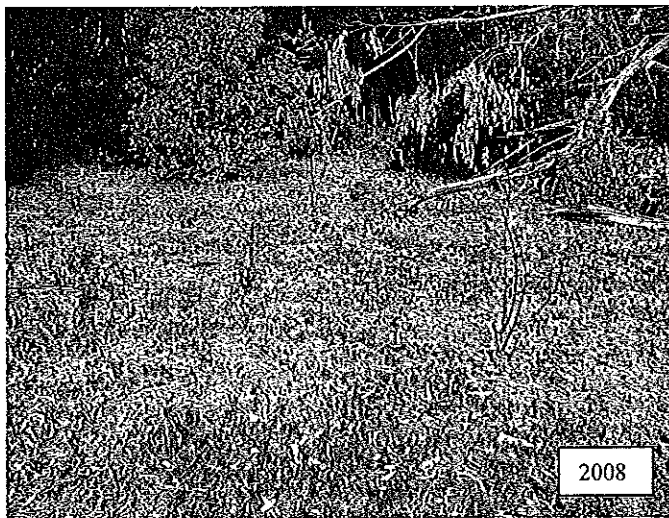
Figure 21B. View of Sample Plot 15, September 2008. Herbaceous/bare cover is 80%; shrub cover is 10%, tree cover is 10%.
